Intel® Celeron™ Processor Specification Update

Release Date: November 1998

Order Number: 243748-008

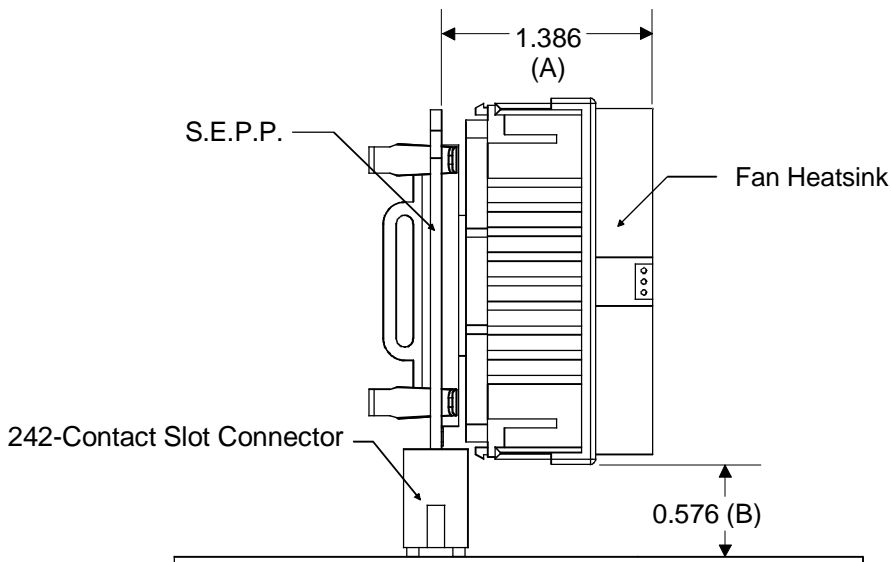
Figure 20. Side View Space Requirements for the Boxed Processor

Figures 20, 21, and 22, and Table 34 of Section 6.2 of the *Intel® Celeron™ Processor at 266 MHz, 300 MHz, 300A MHz, and 333 MHz* datasheet show incorrect fan heat sink dimensions for the boxed Intel Celeron processor. The correct figures and table are shown below.

The maximum depth of the fan heat sink to the processor substrate should be 1.386", not 1.291" max. The minimum height clearance above the baseboard should be 0.576", not 0.485". The fan shroud height should be 2.02" and 4.74", respectively, not 2.19" max. and 4.90" max. Figure 22 should show reference "G" for the minimum airflow keepout zone from the inlet of the fan heat sink, and reference "F" for the minimum airflow keepout zone from the ends of the fan heat sink.
